# **URETEK** TEST PROJECT: HWY 696 PEDESTRIAN PLAZA BRIDGES SEALING

**MICHIGAN  
DEPARTMENT OF  
TRANSPORTATION**

**Location**  
Detroit, Michigan

**Date of Project**  
2006

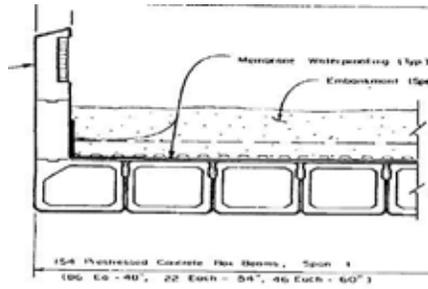
ABOVE: Diagram of section bridge's construction.

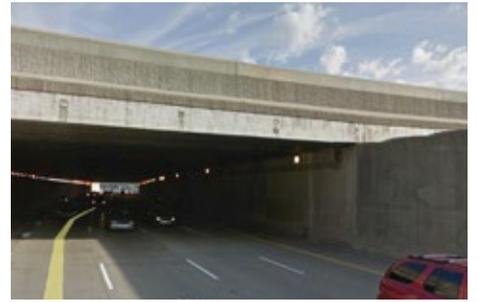
ABOVE: Section of bridge on I-696.

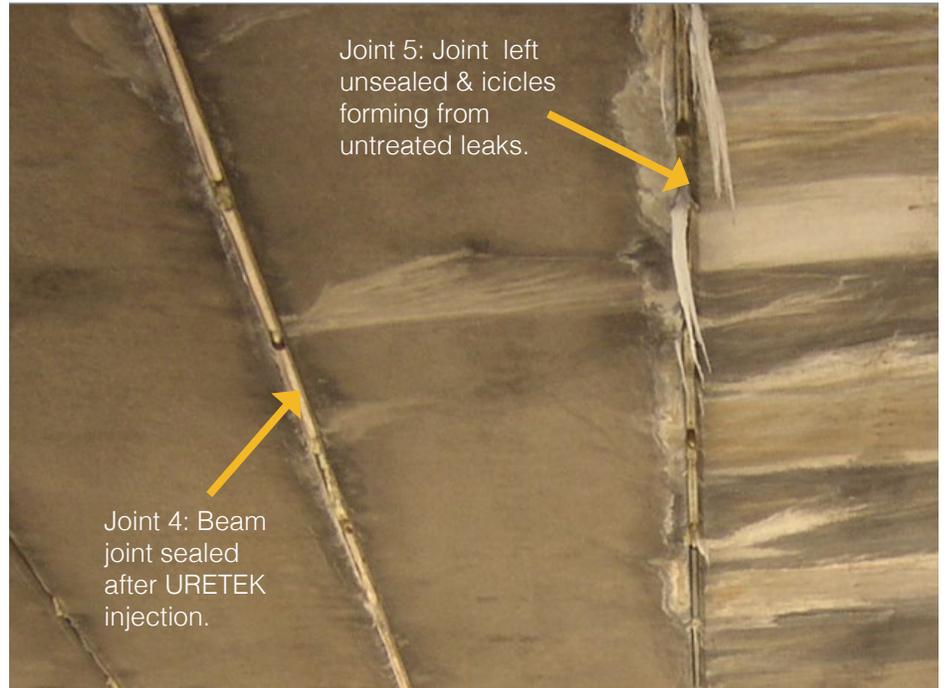
URETEK completed void filling and sealing the 4 joints successfully. Once weather temperatures cooled the test results showed that the polymer successfully sealed the joints and prevented the icicles from forming within.

*(See picture above comparing the joint (Joint 5) that was left open compared to the sealed joint that was next to it.)*

The URETEK technicians injected above and in between the concrete beams on 4 joints in a section that went over a pedestrian walkway. The 5th joint was left alone in order to test if URETEK's solutions were successful.
