WEIS MARKETS

Location
Linglestown, PA USA

Date of Project
2018

RESTORING GREAT CUSTOMER EXPERIENCES

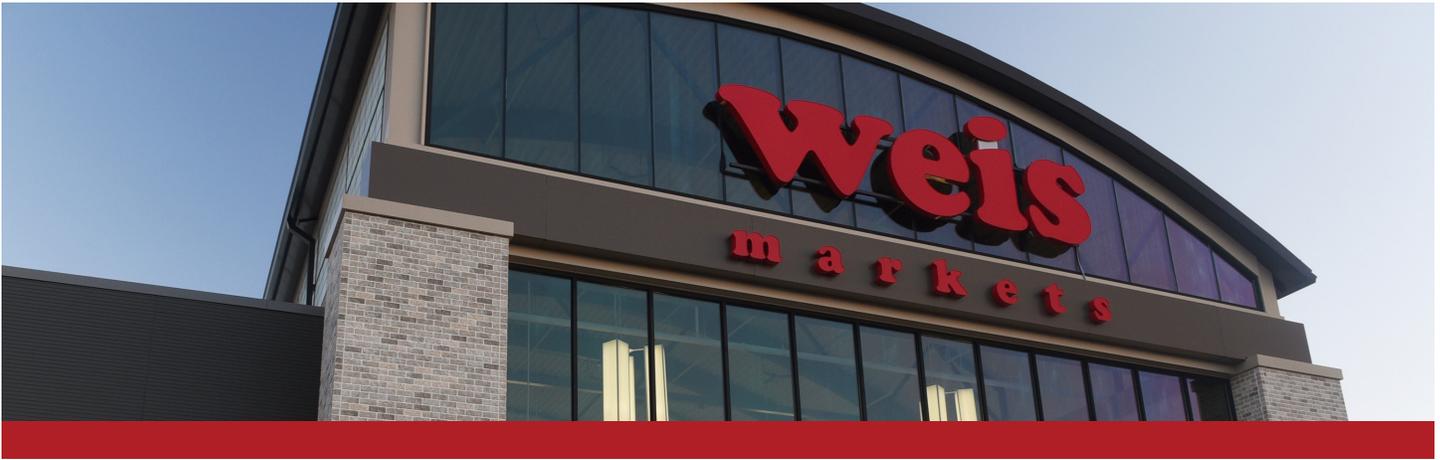
A major trip hazard appeared along the sidewalks and curbing, of the Linglestown, PA Weis Market Grocery store.

Built above a culvert, the sidewalks on both sides of the store entrance, including a safety railing, had settled causing a substantial safety-related tripping hazard to the public and customers alike.

About 70 sections of sidewalk, representing approximately 210 linear feet, were affected—with some settling as much as 3.5 inches. Additionally, there was a metal railing that had been attached to the sidewalk when the sidewalk was poured.

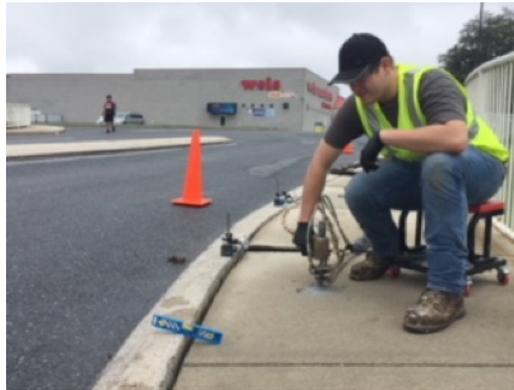
Doing the Project: The URETEK technician is injecting the material beneath the sidewalk slabs, taking care to keep everything aligned and without disturbing the metal railing in the background.

The URETEK team drilled small 5/8" (penny size) holes then injected structural grade and environmentally friendly polymer underneath each sidewalk panel. In some cases multiple applications and injections were needed due to degree of settlement and lift needed.

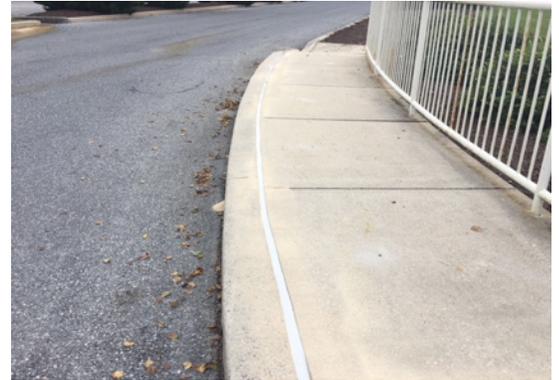
The Final Result: The same section of sidewalk slabs lifted, aligned and gaps sealed.

It looks and functions like new.

Upon completion of the sidewalk lifting, every injection point was sealed as were any gaps between sidewalk panels or between the sidewalk panels and adjacent curbs.
